Performance of Horizontal Infrastructure in Christchurch City through the 2010-2011 Canterbury Earthquake Sequence

March 2014

Summary

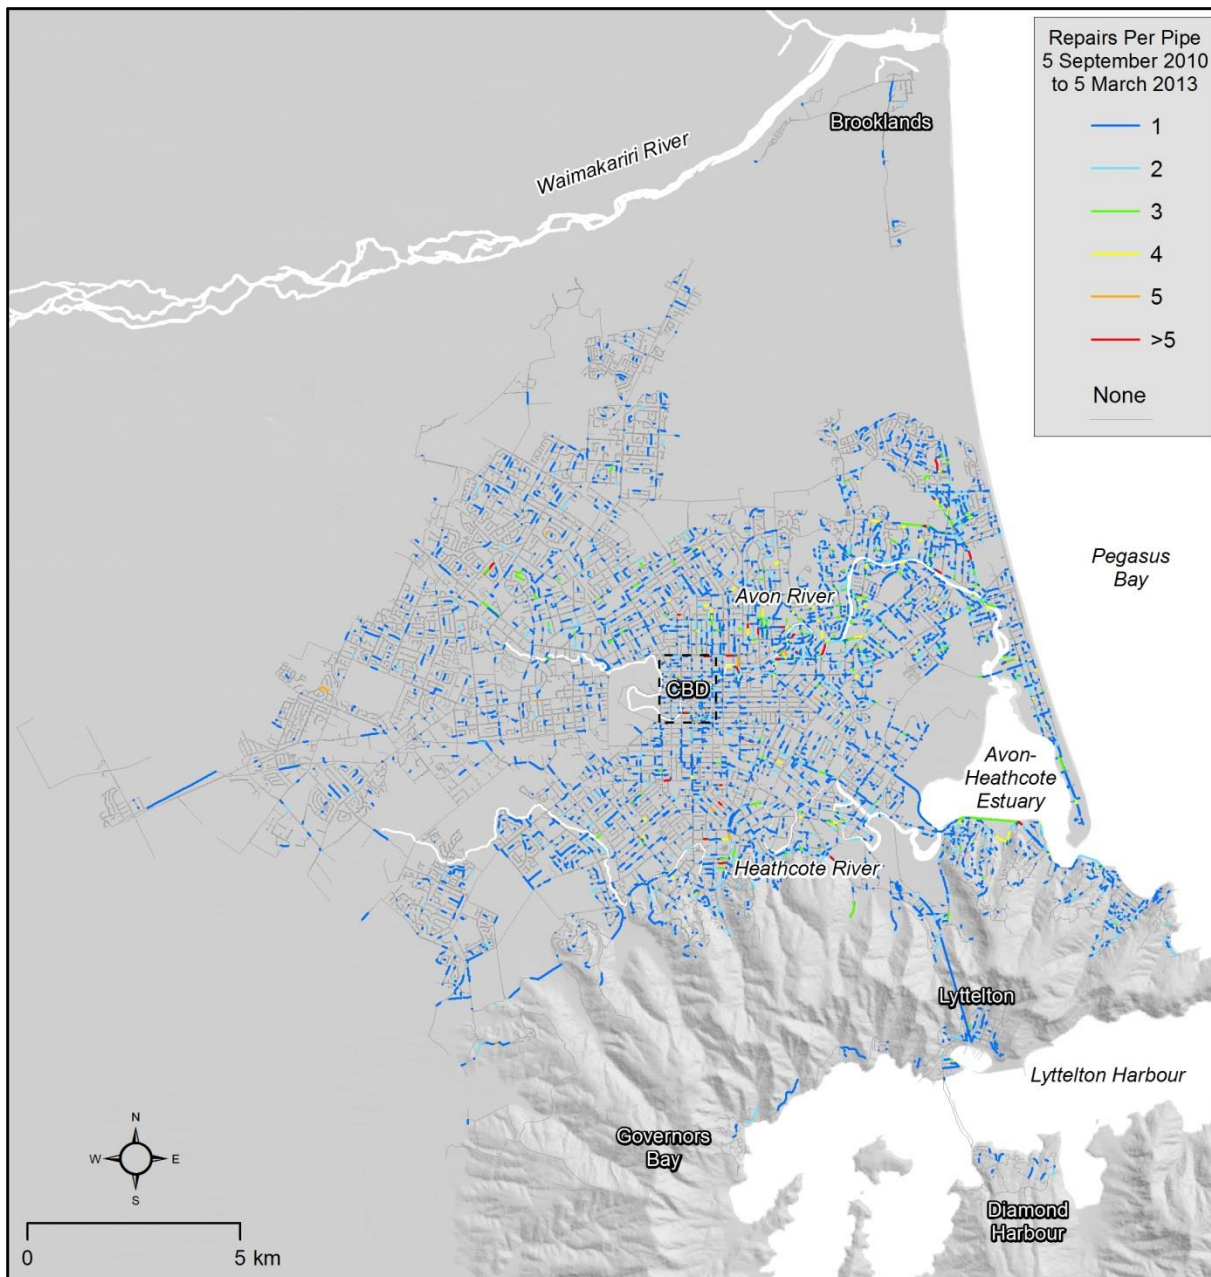
Figure 9. Numbers of repairs per pipe in Christchurch City and Lyttelton Harbour over the period 5 September 2010 to 5 March 2013.

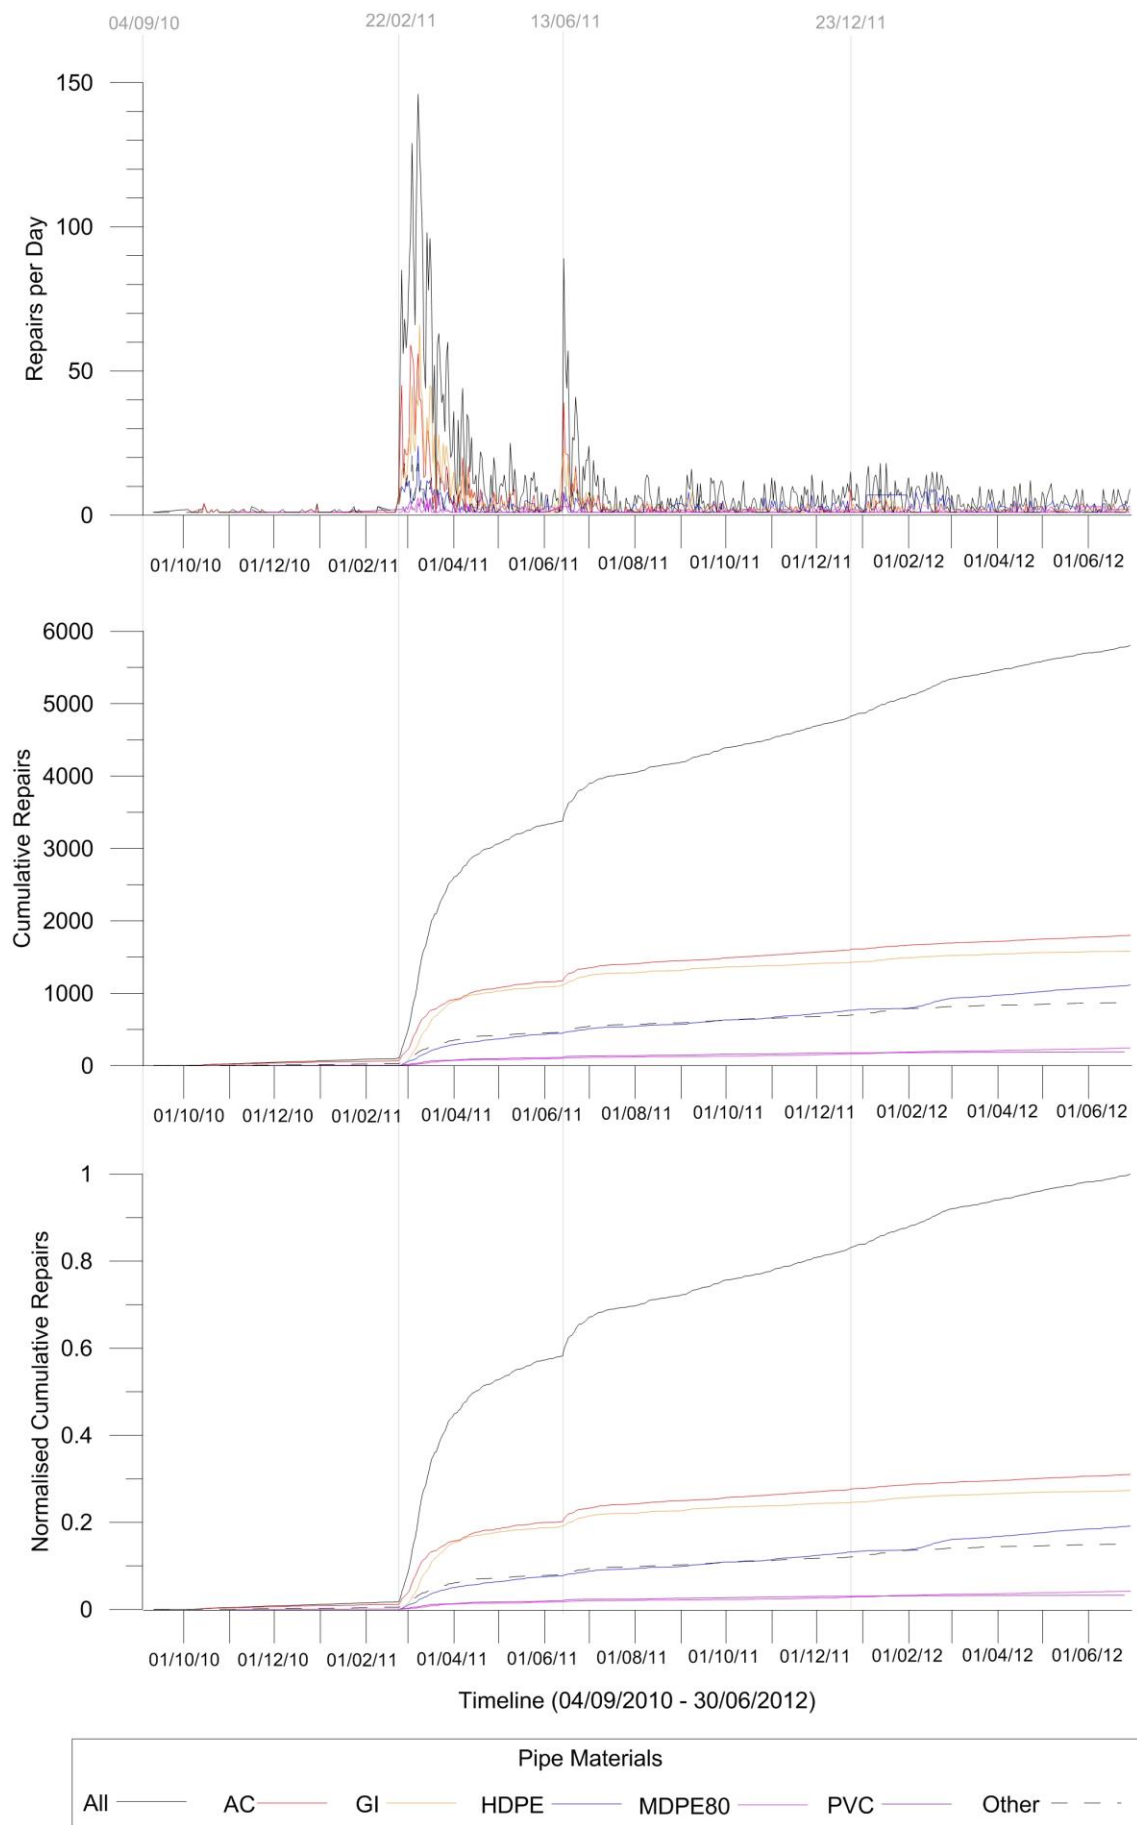
Here we present updated daily repair counts and cumulative repair plots for the period 5 September 2010 to 30 June 2012 (Figure 12). As seen in previous summaries (O'Rourke et al., 2012, 2013; Cubrinovski et al., 2013) there were significant numbers of repairs in the weeks after 22 February 2011 and 13 June 2011, but no apparent comparable increase after 23 December 2011.

Figure 12. Daily potable water repairs through the CES, presented as daily counts (top), cumulative counts (middle) and normalised cumulative counts (bottom).

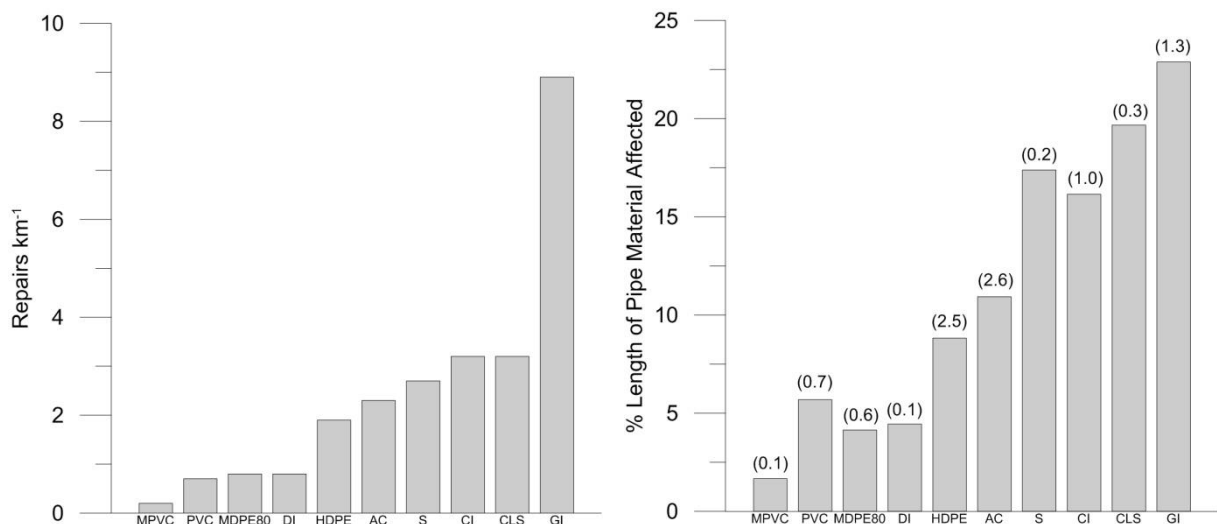
Repairs for pipe materials across Christchurch City and Banks Peninsula are presented in Figure 13 in order of increasing repairs km^{-1} . MPVC, PVC, MDPE80 and DI had <1 repair km^{-1} , HDPE had 1.9 repairs km^{-1} , AC and S had 2.3 and 2.7 repairs km^{-1} , respectively, CI and CLS both had 3.2 repairs km^{-1} , and GI had the highest rate of 8.9 repairs km^{-1} .

Figure 13. Left: Summary repair data for different pipe materials. Right: Percentage length of each pipe material affected by CES damage. Affected percentage length of the the entire network is presented in parantheses.

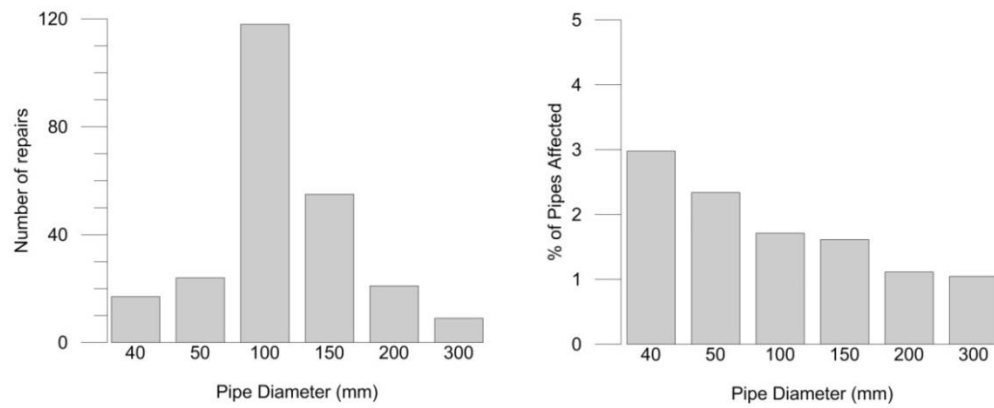
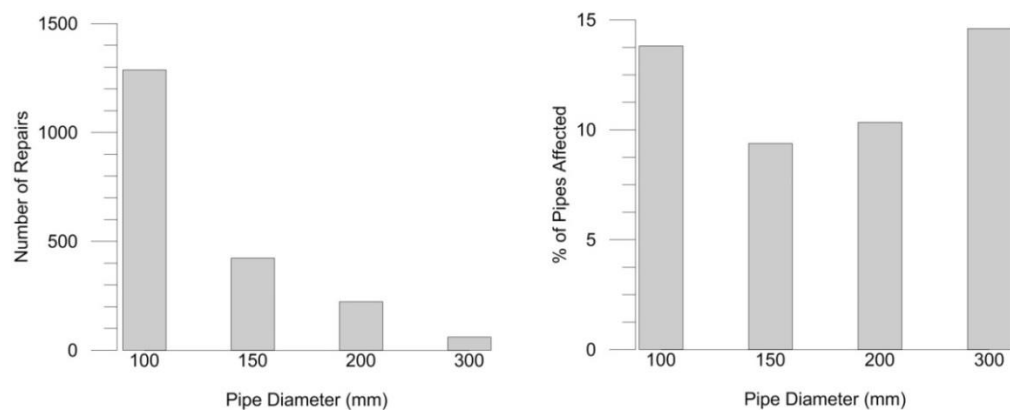
Up to the commencement of the CES on 4 September 2010, AC pipes comprised a significant component of Christchurch's mains system (approximately 771 km length). Different AC diameters showed distinct differences in repair rates (Figure 14b). 100 mm mains had a rate of 3.1 repairs km^{-1} , 150 mm and 200 mm pipes and similar rates of 1.7 and 1.8 repairs km^{-1} , respectively, and 300 mm diameter pipes had a rate of 1.2 repairs km^{-1} . See Appendix C for all tables of repair rates for each diameter class within each pipe material category.

Figure 14. Repair data for PVC (a) and AC (b) pipes according to pipe diameters. Data cover the period 5 September 2010 to 5 March 2013.

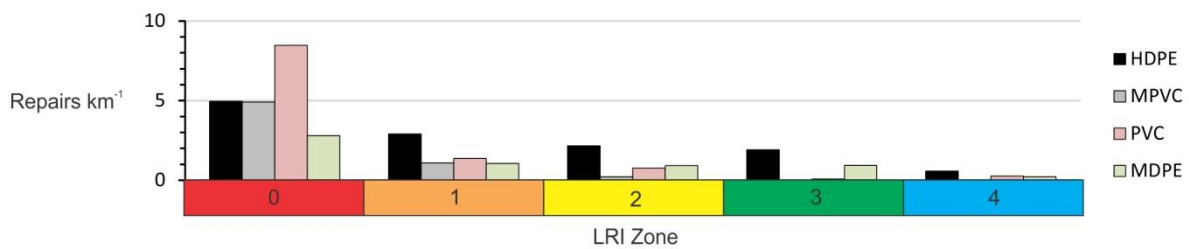
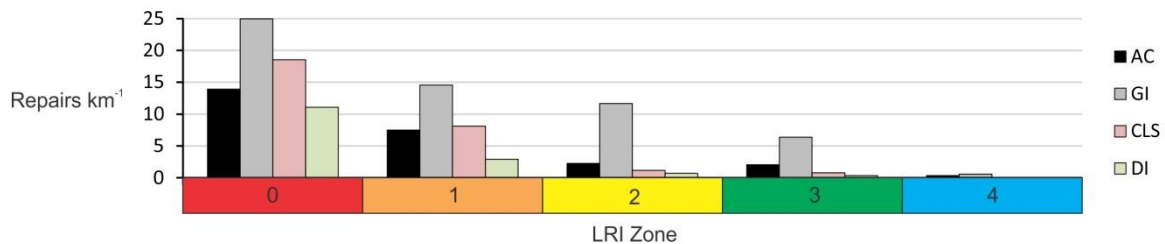
Figure 15. Summary repair data for the potable supply network within Liquefaction Resistance Index zones (see Figure 10). Data cover the period 5 September 2010 to 5 March 2013.

A subset of the water network repair data within the LRI analysis area (Cubrinovski et al., 2011; 2013) shows clearly that for all pipe material types, there is a consistent decrease in repair rate from LRI Zone 0 to LRI 1 (Figure 15 and Figure 16) and further decrease in repair rates with increasing liquefaction resistance (*LRI*). Unfortunately the highly variable numbers of pipes with different diameters with LRI zones makes it problematic for rigorous comparisons with regard to pipe diameters. However, data indicate that there is an overall decrease in repairs km^{-1} with increasing pipe diameter, particularly for PVC and AC (Appendix E).

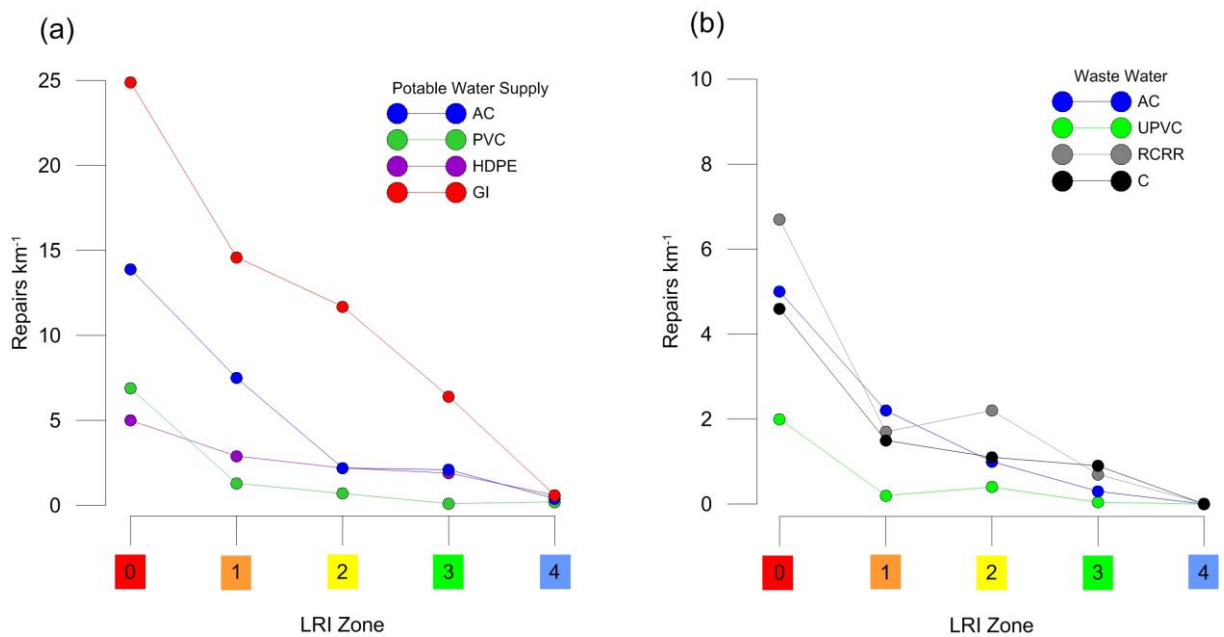
Figure 16. Summary repair data for dominant pipe materials for the potable water supply system (a) and the waste water system (b) in different LRI Zones. AC= Asbestos Cement

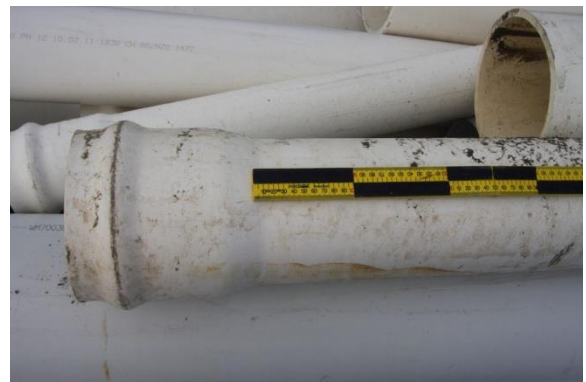
Figure 26. PVC mains. Photo: M. Hughes.

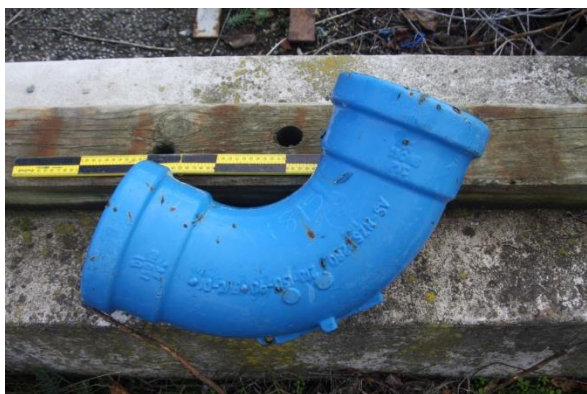
Figure 27. Mains bend. Photo: M. Hughes.

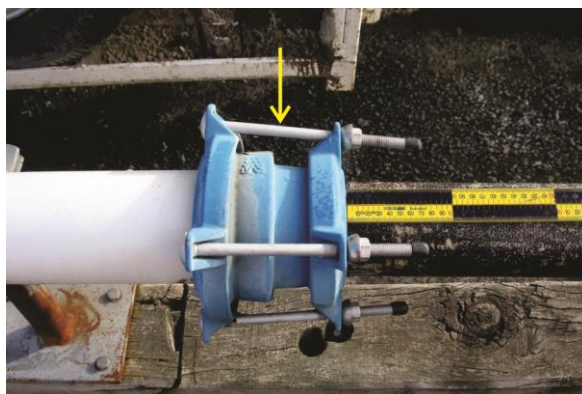
Figure 28. Gibault (indicated) joining two pipes. Photo: M. Hughes.

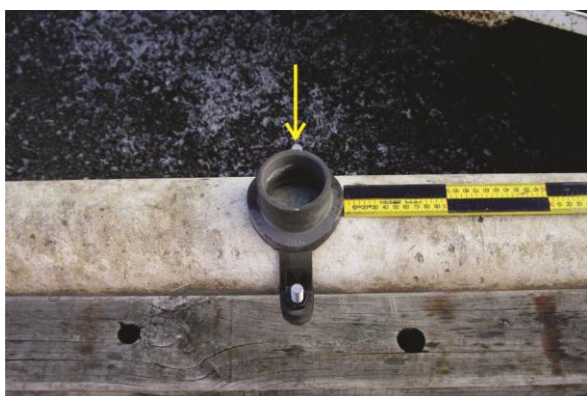
Figure 29. Pipe connection (indicated), into which submains are connected. Photo: M. Hughes.

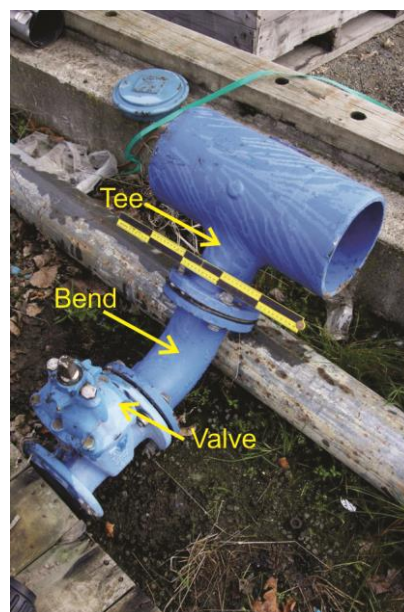
Figure 30. Mains tee, bend and valve. Photo: M. Hughes.

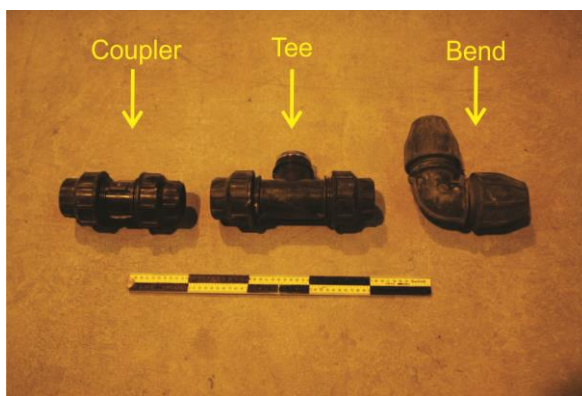
Figure 32. Submains fittings: coupler, tee and bend. Photo: M. Hughes

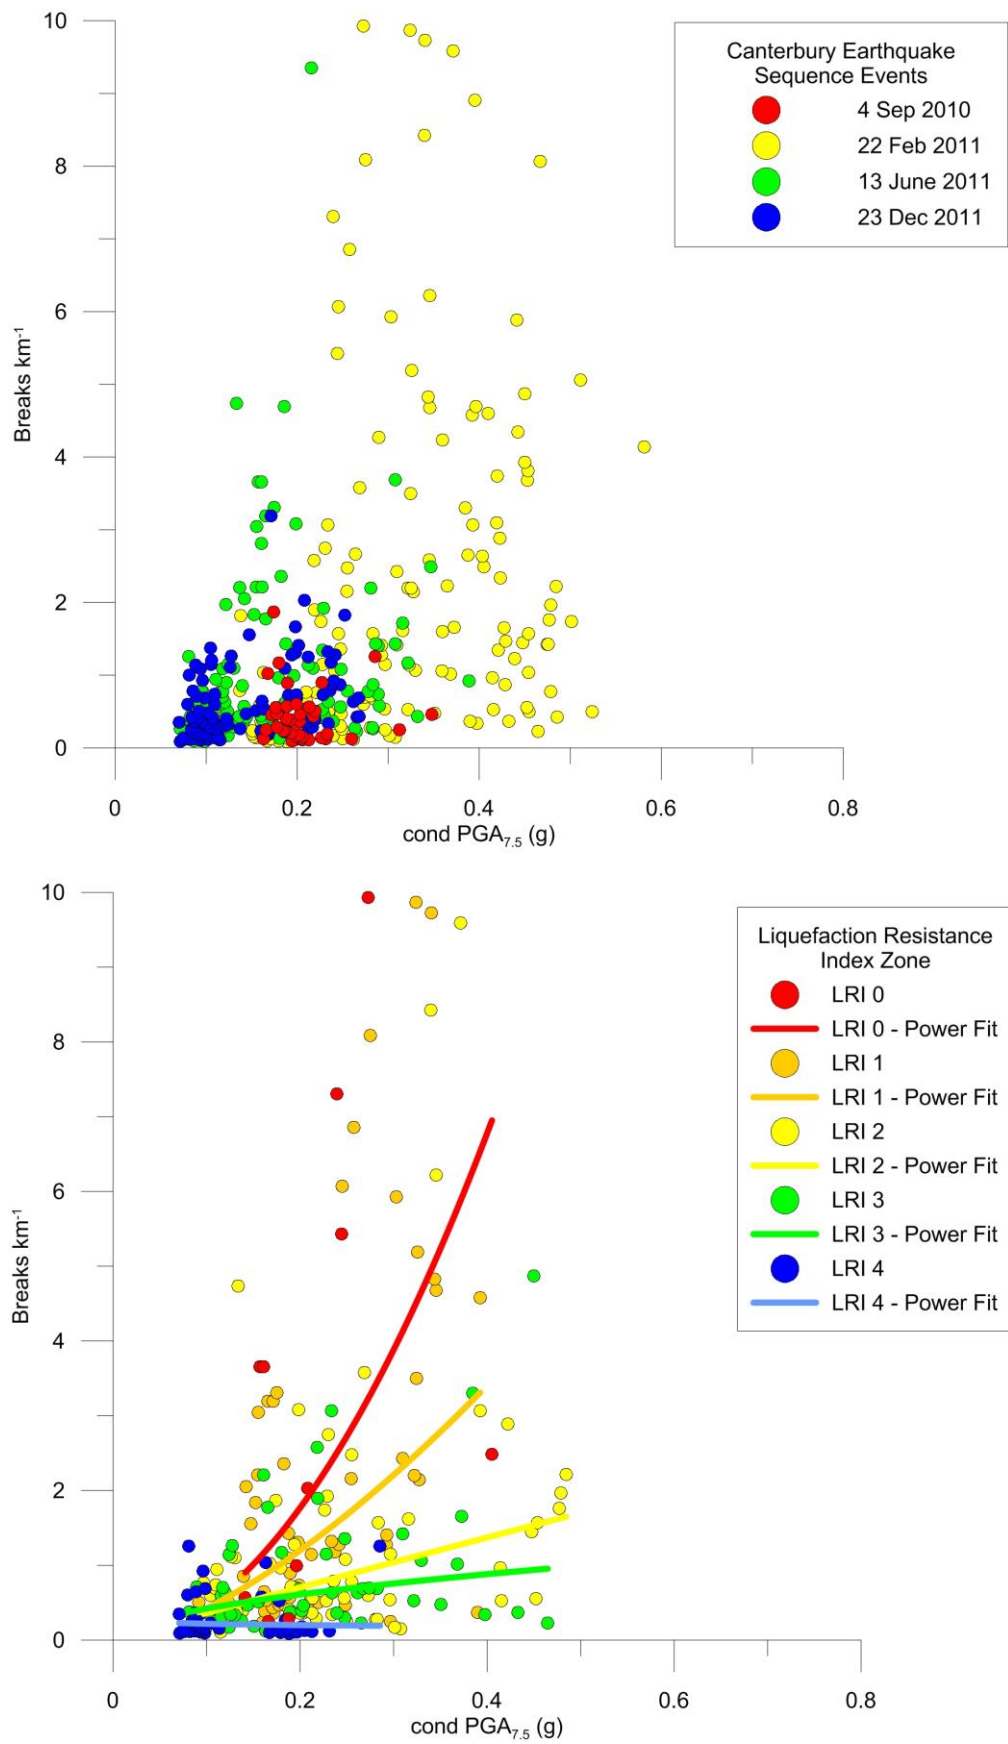
The extent of transient and permanent ground deformation induced by liquefaction depend upon local soil and groundwater conditions captured in the LRI. Figure 37 (bottom graph) shows AC breaks km^{-1} versus $PGA_{7.5}$ discriminating between different LRI zones, with logarithmic power curves fitted for each set of *LRI* zone data. Despite the scatter evident in the data, for a given $PGA_{7.5}$ value breaks per km are in general higher in zones with lower liquefaction resistance or LRI, with a consistent trend in the relationship as a function of *LRI*.

Figure 37. PGA_{7.5} versus breaks km⁻¹ for AC pipes across Christchurch City. Top: Data plotted according to CES events. Bottom: Data plotted according to LRI Zone, with power curves fitted. Power fit equations are presented in Table 4. Note that data points outside of the LRI Zones are excluded.

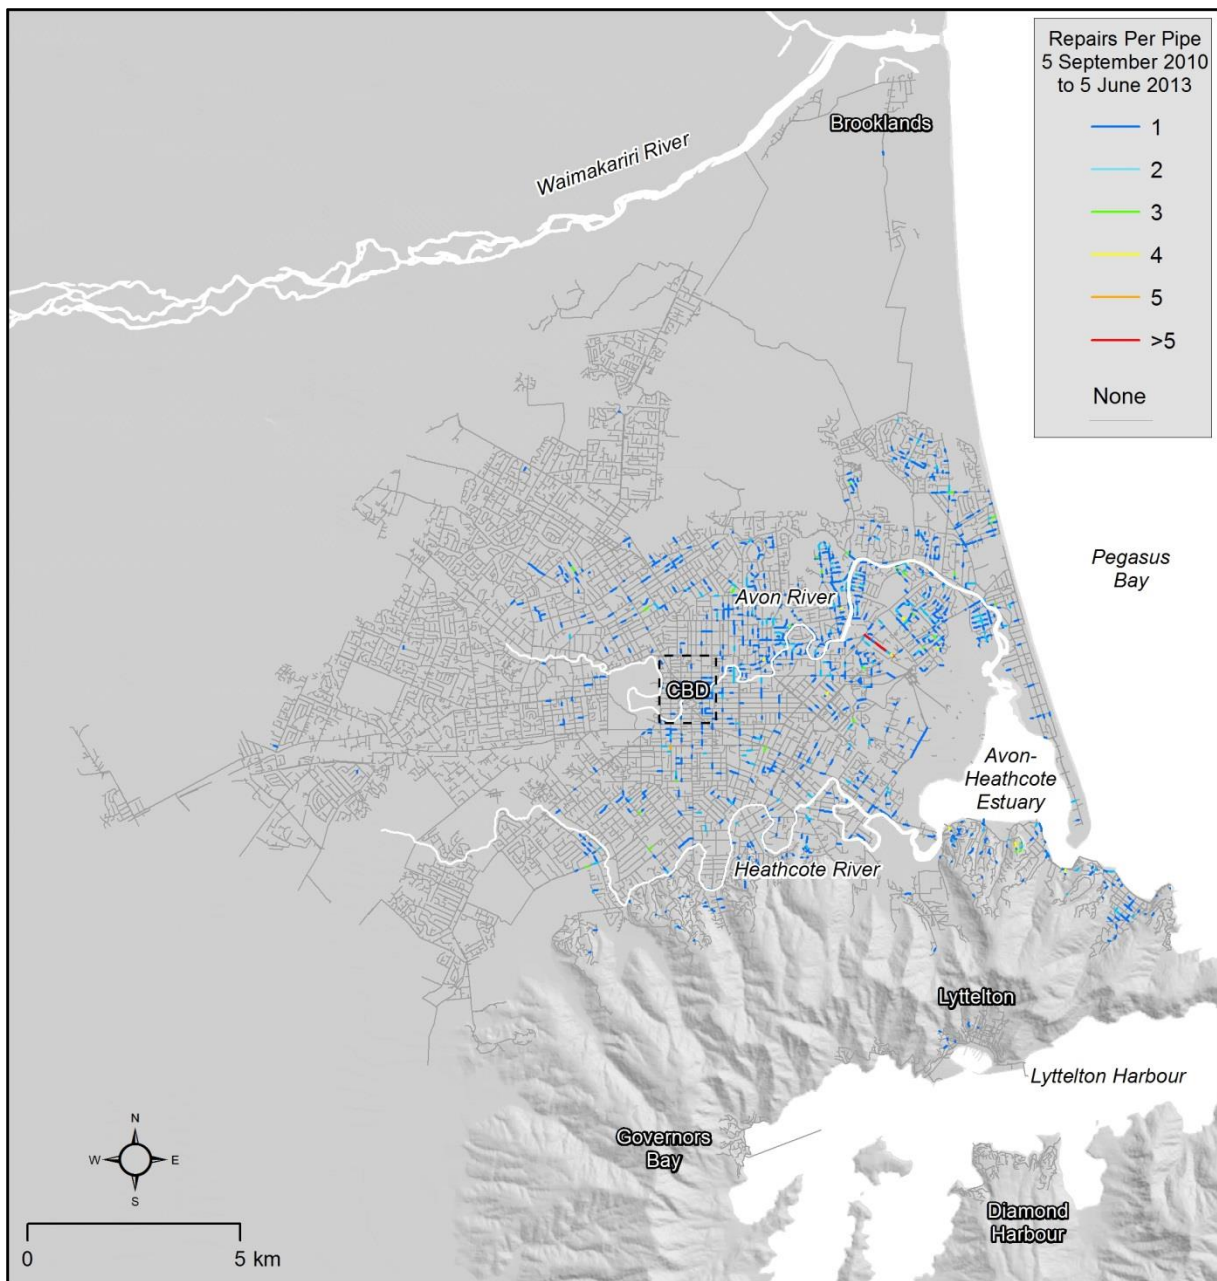
Pipe repair count data used here were obtained from SCIRT's GIS team on 11 March 2013, and represent the most accurate picture of the system's spatial distribution and specifications up to this point. The data were in the form of a polyline shapefile, with number of repairs per pipe for the period 5 September 2010 to 5 June 2013 ascribed to each pipe record (see Figure 41). These repair count data represent <5% (~80 km) of total system length.

Figure 41. Numbers of repairs per pipe in Christchurch City and Lyttelton Harbour over the period 5 September 2010 to 5 June 2013.

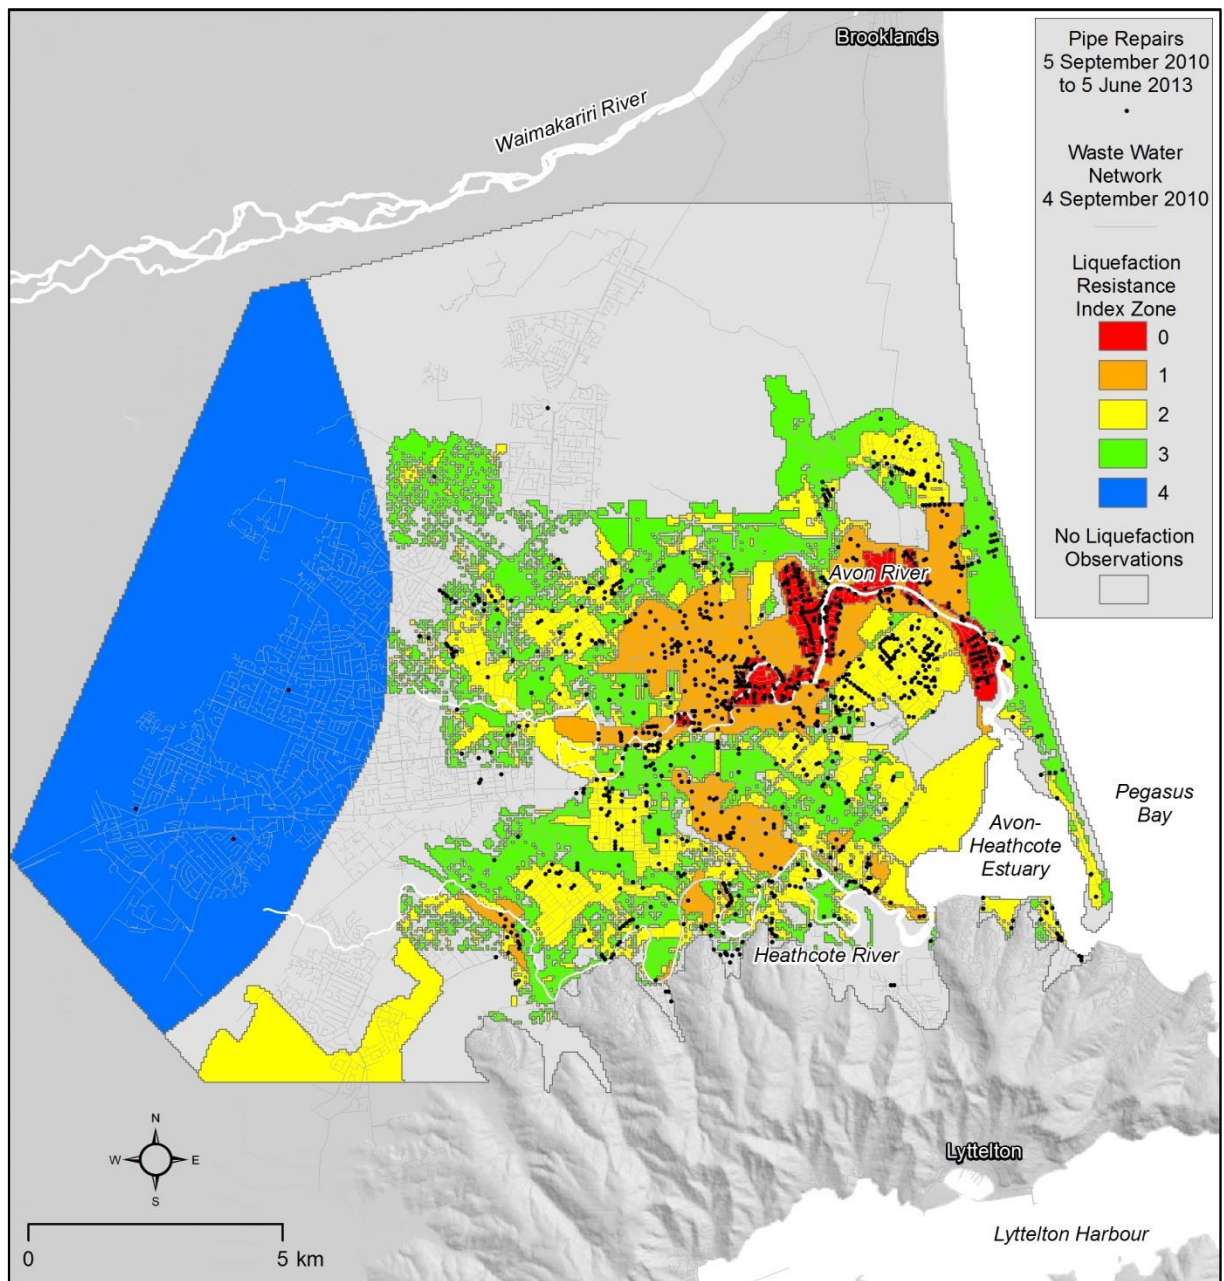
Pipe material performance according to LRI was determined. To avoid difficulties where an individual pipe traversed the boundary between two LRI zones, the mid-point of each pipe was defined (half-way along pipes of any length) and intersected with the LRI map (see Figure 42). For each major network pipe material within each LRI zone numbers of repaired pipes, affected lengths, total repairs and repairs per km were calculated for each diameter class.

Figure 42. Locations of repaired waste water pipe midpoints within the LRI analysis area, and LRI zones. See Table 2 for LRI Zone ground deformations.

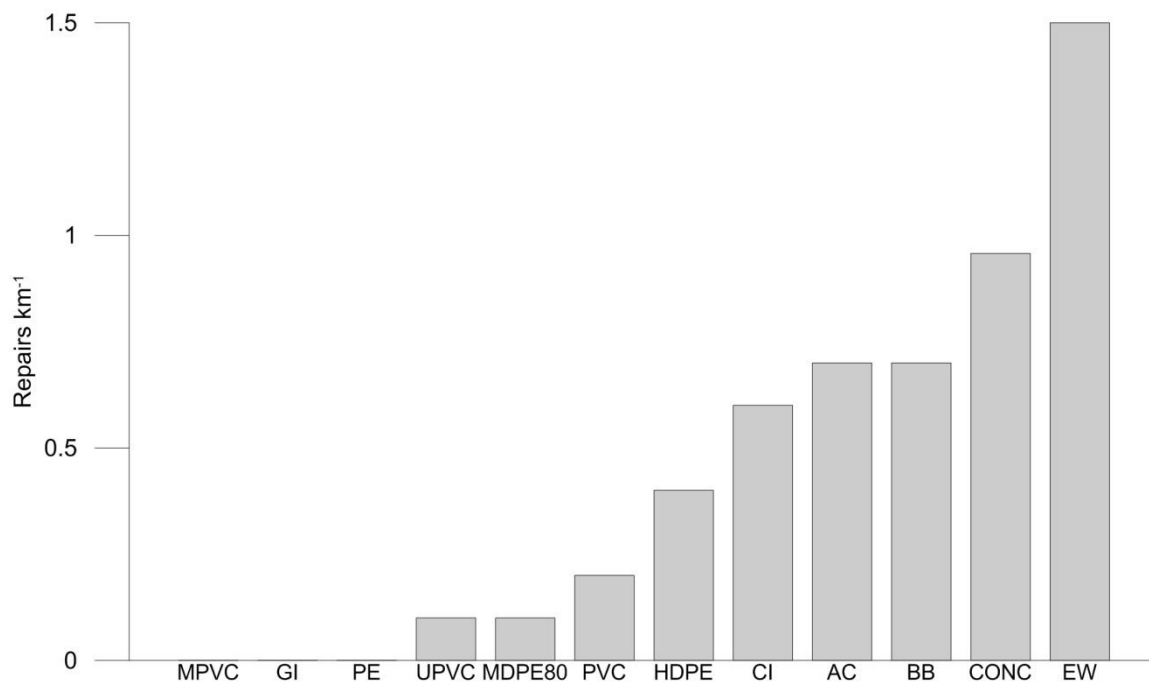
Repair records to date represent only a small percentage of the network that will ultimately be repaired and replaced, and therefore the calculated repairs rates must be considered preliminary. Affected lengths for CONC and EW are ~43 km and ~35 km, respectively. Affected lengths for AC and UPVC are ~6 km and ~3 km, respectively (Figure 43). The remainder of affected lengths for the repaired pipes of other materials are all <1 km in length. EW pipes had the highest repair rate of 1.5 repairs per km followed by CONC (1.0 repairs per km) and AC (0.7 repairs per km).

Figure 43. Summary repair data for waste water pipe materials. Data cover the period 5 September 2010 to 5 June 2013.

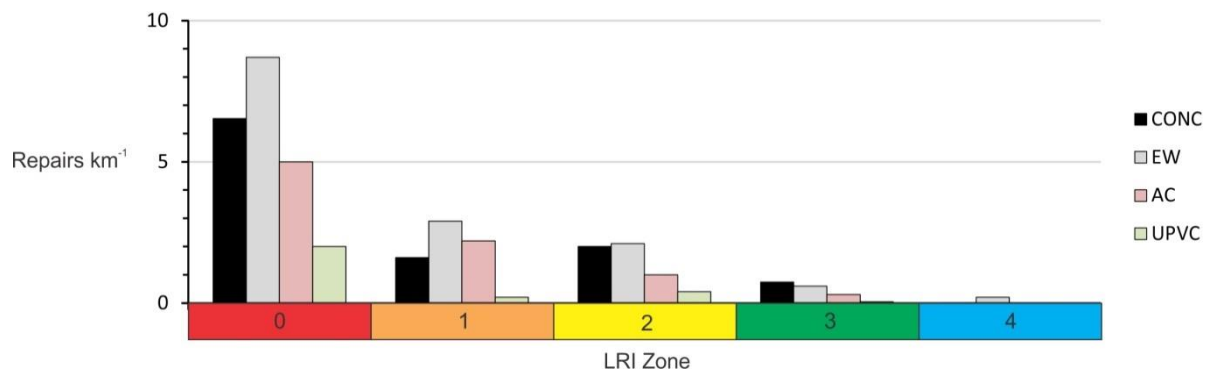
A subset of the water network repair data within the LRI analysis area (Cubrinovski et al., 2011; 2013) shows that for most pipe material types there is a consistent decrease in repair rate from LRI Zone 0 to LRI 3 (Figure 44). There is a clear link between LRI and repair rate for all pipe materials. Within LRI Zones 0-2, EW had the highest repair rate followed by CONC and AC.

Figure 44. Summary repair data for the four most spatially extensive waste water pipe materials (Concrete, Earthenware, Asbestos Cement and Plasticised Polyvinyl Chloride) within Liquefaction Resistance Index Zones . Data cover the period 5 September 2010 to 5 June 2013.

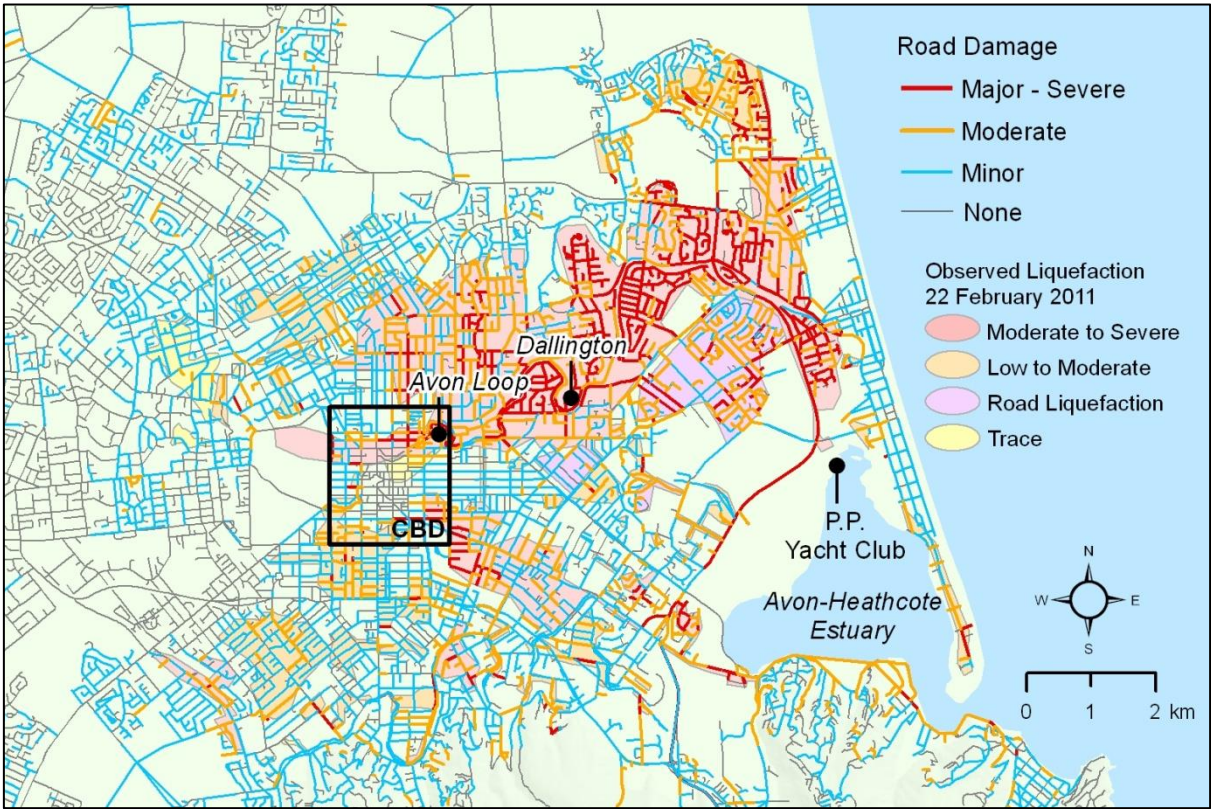
Immediately after the 22 February 2011 Christchurch Earthquake, twelve crews of CCC engineers conducted detailed drive-through reconnaissance, covering nearly all roads in the Christchurch urban area, to assess road damage and estimate the cost of repairs. Over a period of ten weeks, the inspection teams documented data on the damage and made detailed observations on the road surface, kerb/channel and footpath conditions (McNeill & English, 2011). These damage data were compiled and synthesized into the road damage map shown in Figure 46, which indicates three levels of road damage: major, moderate and minor.

Using these road damage data in conjunction with the liquefaction map presented in Figure 7 (Top) (also shown in the background of Figure 46), a geospatial analysis was performed using GIS to correlate the severity of road damage with the liquefaction severity. The results of the analysis indicate a very strong correlation between the level of road damage and severity of liquefaction manifestation (Table 7). Practically all major damage to roads (i.e. 97%) occurred in areas of moderate or severe liquefaction; 80% of the moderate road damage occurred in areas of moderate to severe liquefaction, while the remaining 20% of the moderate road damage was observed in areas of minor or no liquefaction manifestation. The minor road damage was spread over the entire area of Christchurch, reflecting the high levels of accelerations and ground distress caused by the local earthquakes throughout the city.

Figure 46. Christchurch City road damage post-22 February 2011, based on CCC classifications. UC liquefaction observations also shown. From Cubrinovski et al. (2013b).

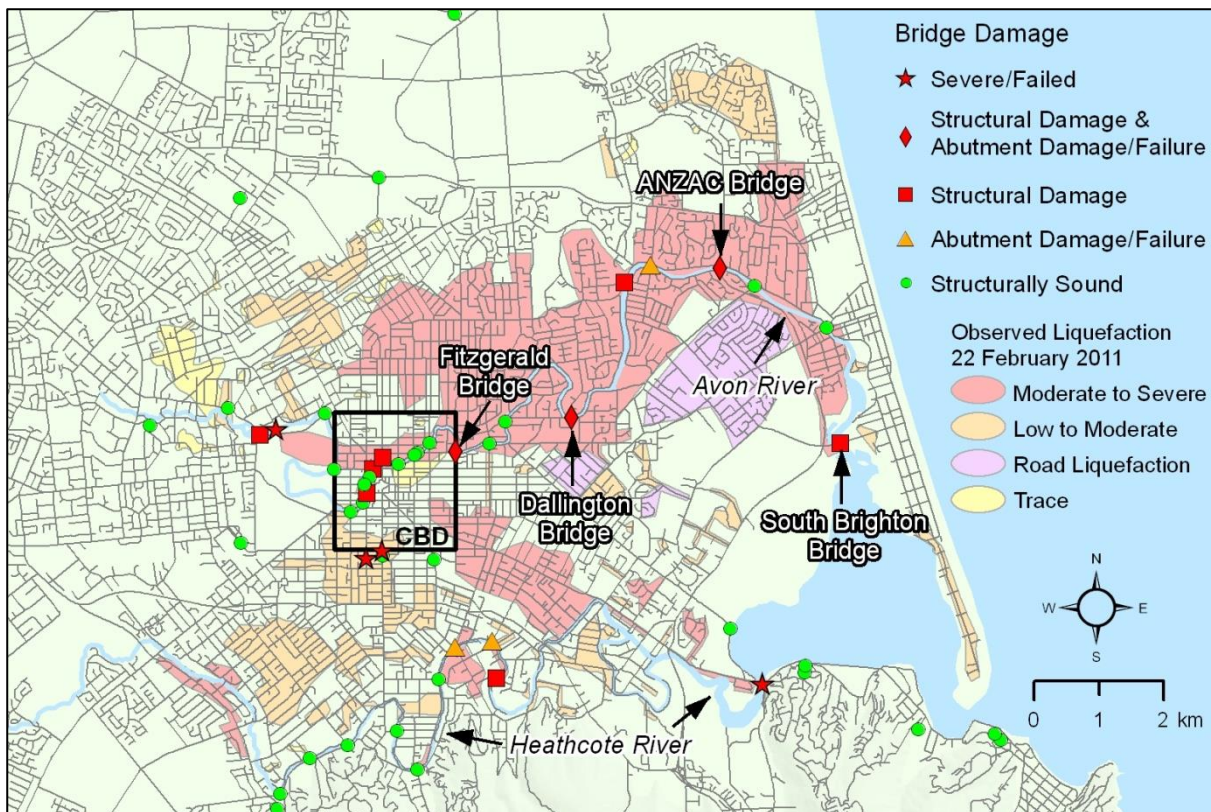
Overall, in the 2010-2011 earthquakes road bridges performed relatively well compared to other engineering structures (Palermo et al., 2011; Wotherspoon et al., 2011). They suffered low to moderate damage and all but one bridge were in service almost immediately after each significant event. A general overview of the damage to road bridges (longer than 10 m) in the urban area of

Christchurch, as judged per visual inspections of Opus engineers for CCC (CCC, 2011b), is depicted in Figure 47.

Figure 47. Bridge damage classifications post-22 February 2011. Data from SCIRT. UC liquefaction observations also shown. From Cubrinovski et al. (2013b).

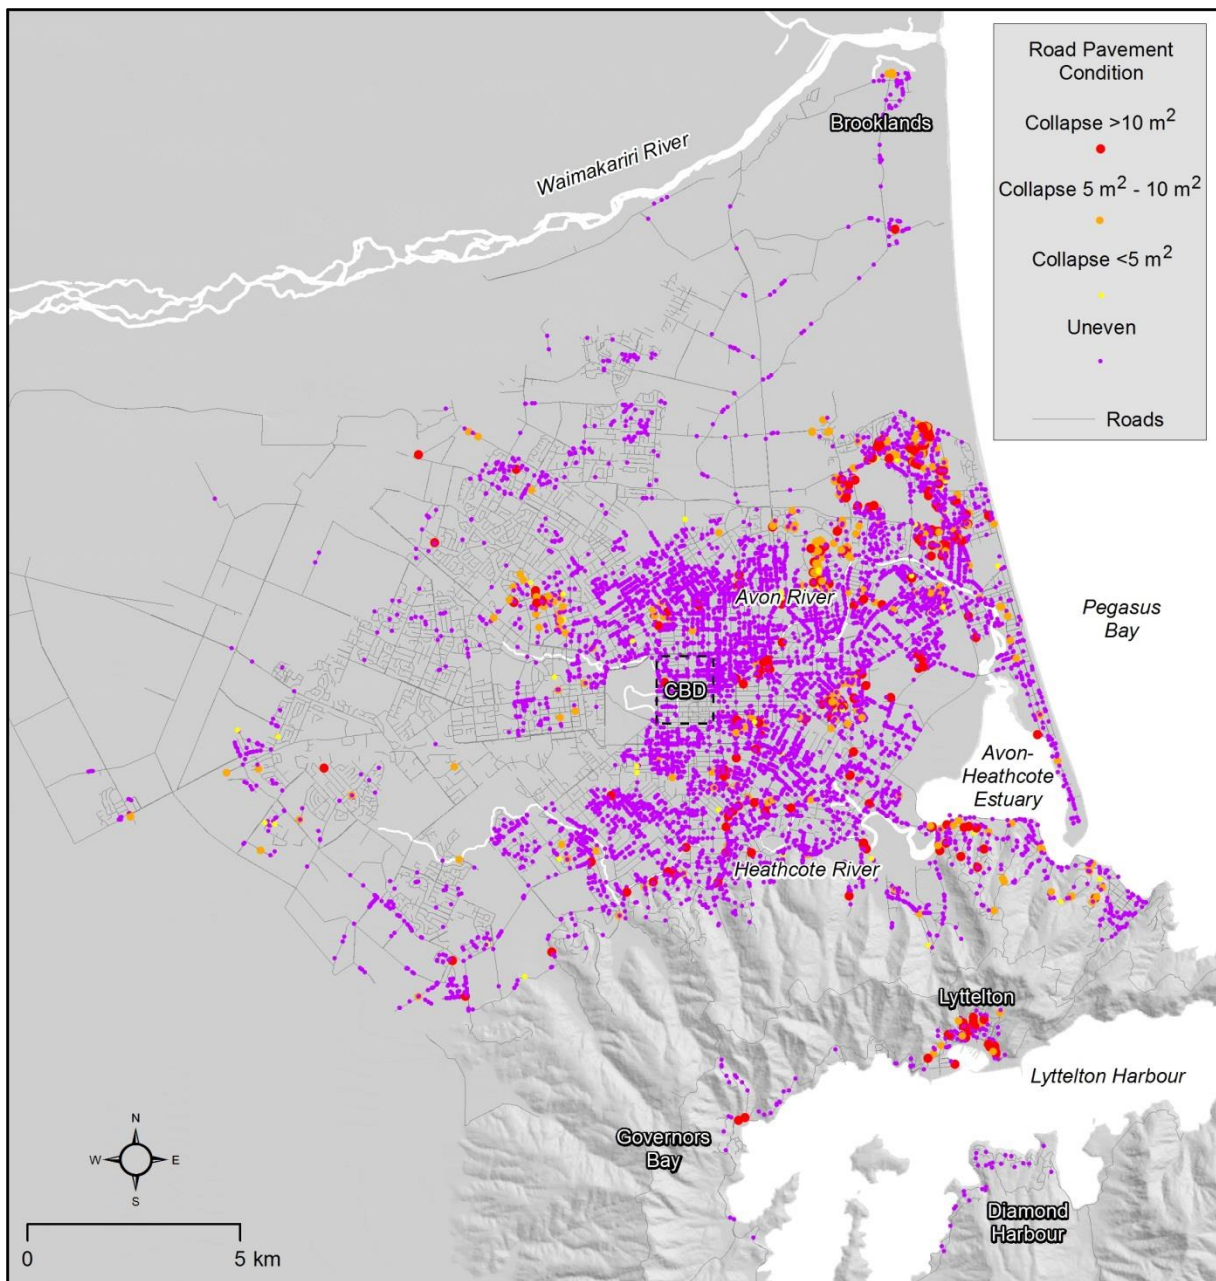
The road damage data collection conducted by CCC included road pavement condition that described the areal extent of identified road surface collapses ($>10 \text{ m}^2$, $5\text{--}10 \text{ m}^2$, $<5 \text{ m}^2$) and locations of road surface unevenness (Figure 48). In addition, observations after rainfall events identified locations of water ponding on road surfaces that had not occurred prior to the CES (Figure 49).

Figure 48. Road pavement condition across Christchurch City after the 22 February 2011 Christchurch Earthquake.

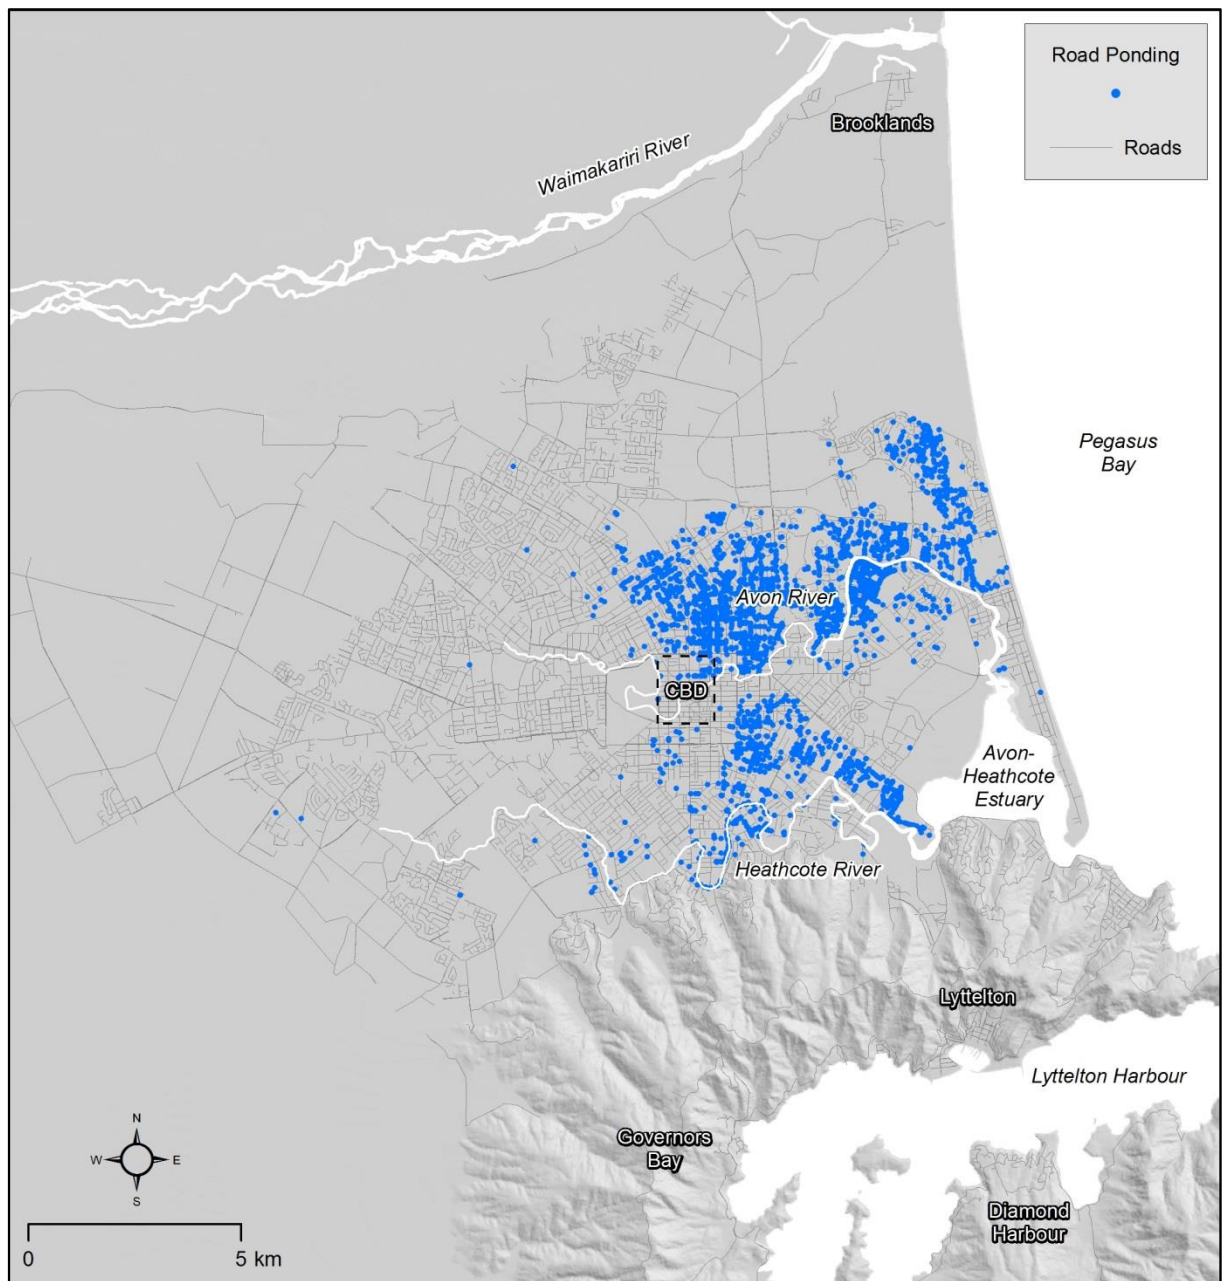
Figure 49. Road ponding across Christchurch City after the 22 February 2011 Christchurch Earthquake.

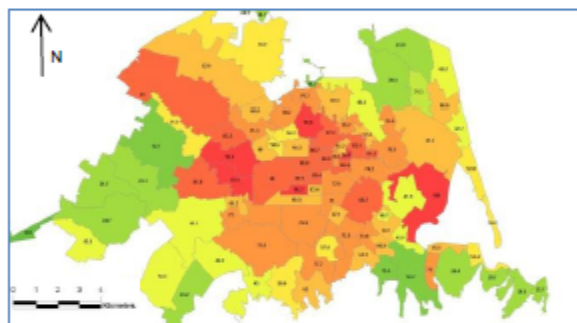
Figure 3: Damage Percentage by Rebuild Area for the Wastewater System

The results for damage percentage are presented as deciles, with red representing high levels of damage (90% to 100%) and dark green representing low levels of damage (0% to 10%)

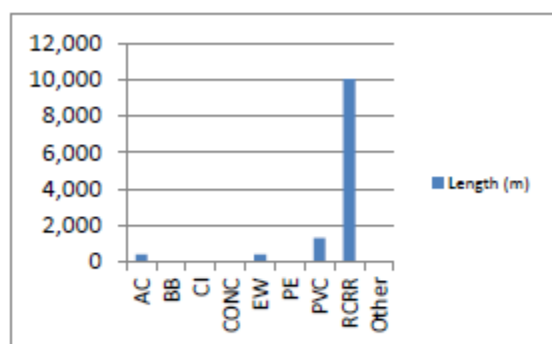
Figure 7: Example of Length of Pipe, Subdivided by Material

Figure 7 shows that the majority of the pipes in the example study area are made from reinforced concrete (RCRR). Figure 8 shows that the least damaged material in the example study area is PVC. Note that the amount of Cast Iron (CI) pipes in the example area is too small to be displayed in Figure 7.

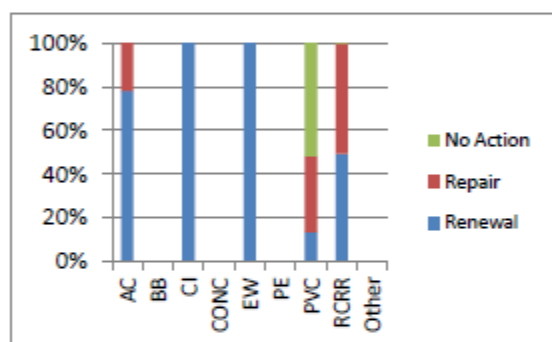
Figure 8: Example of Damage Proportions to Pipes, Subdivided by Material
